Environment, Safety and Health Bulletin

Potentially Defective Battery Charger

DOE/EH-0697

October 2005

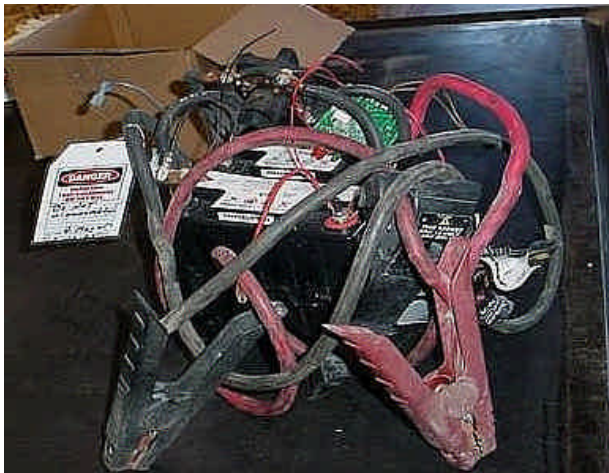
This Safety Bulletin is being issued to alert readers to potential defects in Solar Truck Pac® model ES1224 battery chargers manufactured by Clore Automotive. Specifically, the Office of River Protection at Hanford reported that one of these chargers exploded (Figure 1) following two attempts to jump-start a crane.

Figure 1. The damaged battery charger after the explosion

mechanic connected the battery charger unit to a crane and attempted to jump-start it. He turned the voltage selector switch from 12v to 24v and tried to start it again, but was unsuccessful. He then turned the switch from 24v to OFF and the charger exploded, propelling pieces of the plastic case as far as 25 feet. No one was injured, but three workers, including the maintenance mechanic, reported to the project medical facility with muffled hearing. [ORPS Report RP--BNRP-RPPWTP-2005-0021]

Because this is preliminary information and we have not received specific guidance from the manufacturer, the Office of Environment, Safety and Health recommends that sites examine their inventory of battery charging equipment, removing any Solar Truck Pac model ES1224

units from service to verify the switch design and properly capped cells. If a defective unit is found (i.e., caps not properly seated or old switch design), contact the distributor from which the unit was purchased and report this finding in the Occurrence Reporting and Processing System (ORPS).

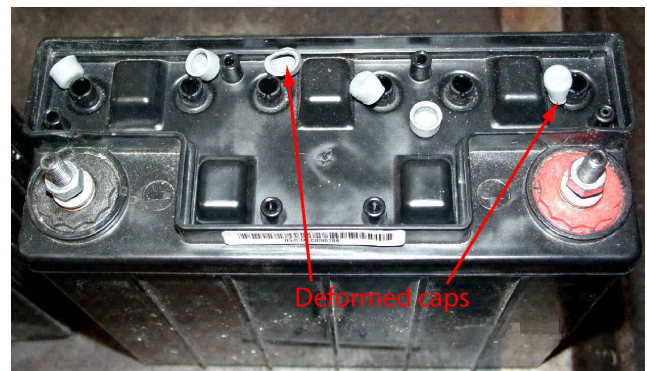
The mechanic and his superintendent examined the remains of the battery charging unit and found that the rubber caps that covered the battery cells had not been properly seated on the cells, and two of the caps were visibly deformed (see Figure 2 below). Also, the case itself did not appear to have been adequately ventilated, and the switch contacts were exposed. Investigators believe that built-up hydrogen gas inside the case was ignited by a spark generated by the exposed contacts.

Figure 2. The uncapped battery charger cells

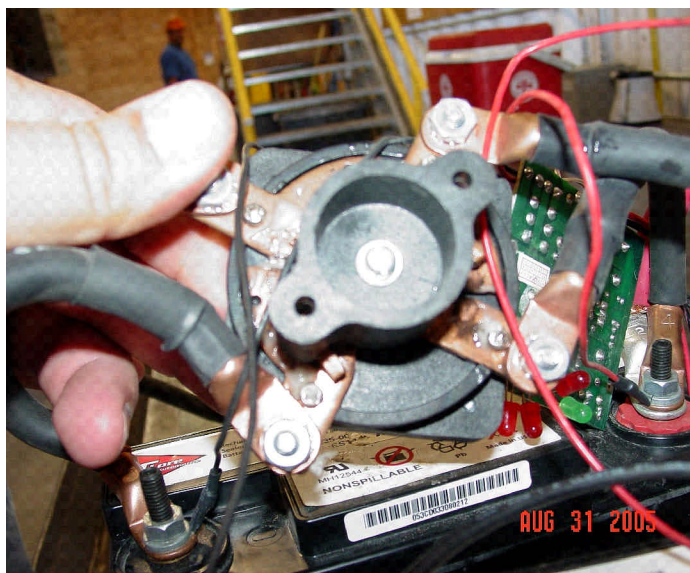
Bechtel, the Waste Treatment Plant construction subcontractor, contacted the manufacturer to obtain more information about this model of battery charger. The manufacturer acknowledged that the switch design has been changed but did not provide additional details about the defect or information about other units that may have exploded. Figures 3 and 4 below illustrate the old and new switch designs.

Figure 3. Old switch design

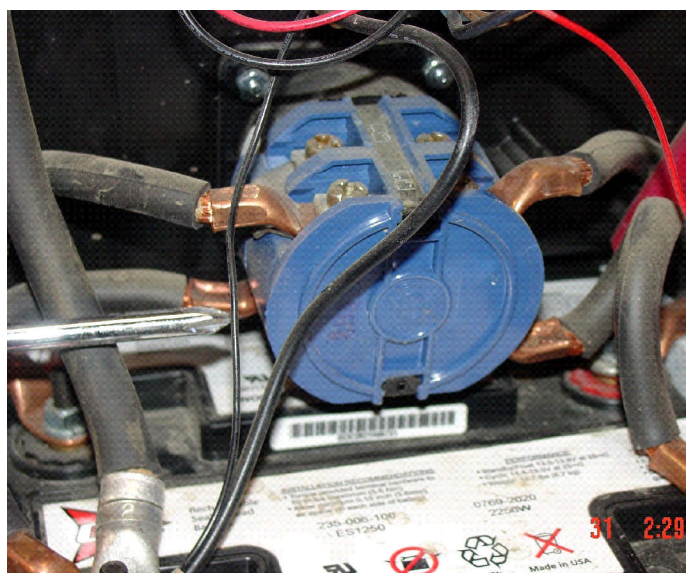
Figure 4. New switch design
